Camera versions

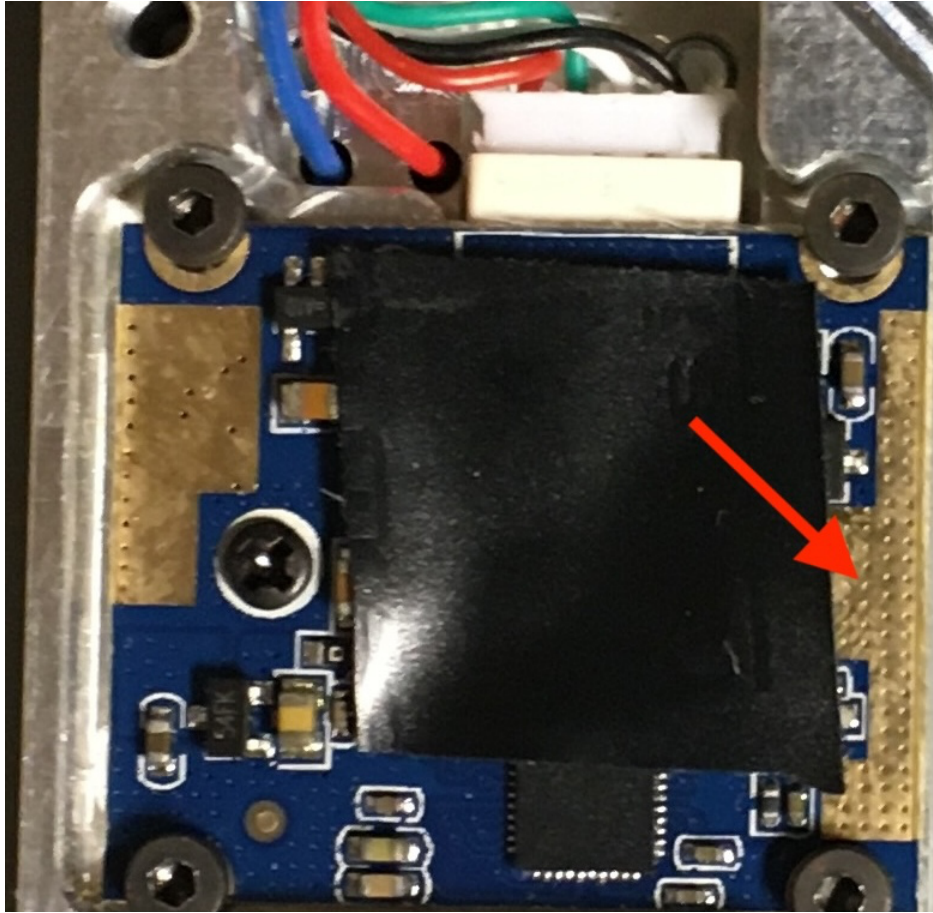
The camera should be gold plated along the side that is closest to the hopper wall as shown in the upper illustration. The camera needs to be replaced if it is only partly gold plated as shown in the lower illustration.
